Amateur Cleanrooms: Costs May Not Offset Benefits
W. Lawrence Ramsey, P.E.
NASA, Goddard Spaceflight Center, Greenbelt Md.
Contamination and Coatings Branch

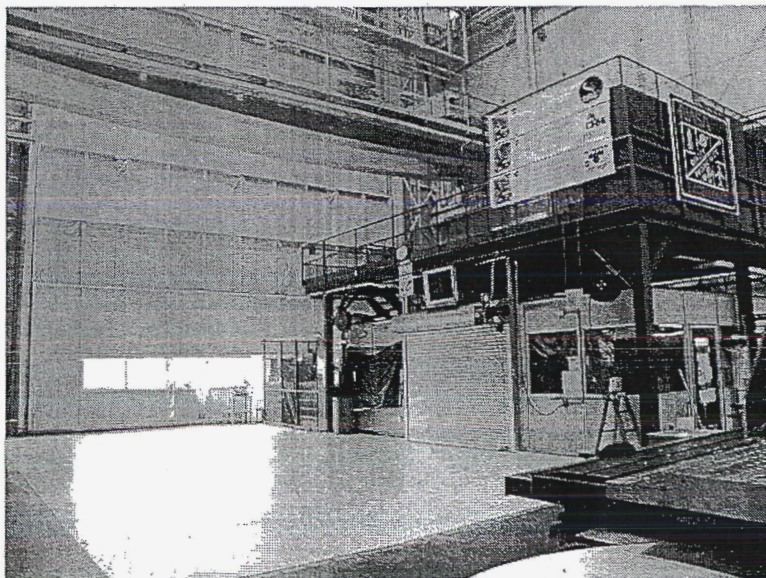
The Yellow Room is a QA lab and store room in a high bay machine shop that was converted to a cleanroom. The conversion was done about thirty years after the area was constructed. Figure 1 shows a view of the room looking toward the rollup door to the exterior and the overhead crane. From this view you can make out the entrance to the room, its poorly fitting rollup door (lower right corner), and tool cage where the ventilation and HEPA filter bank is located.

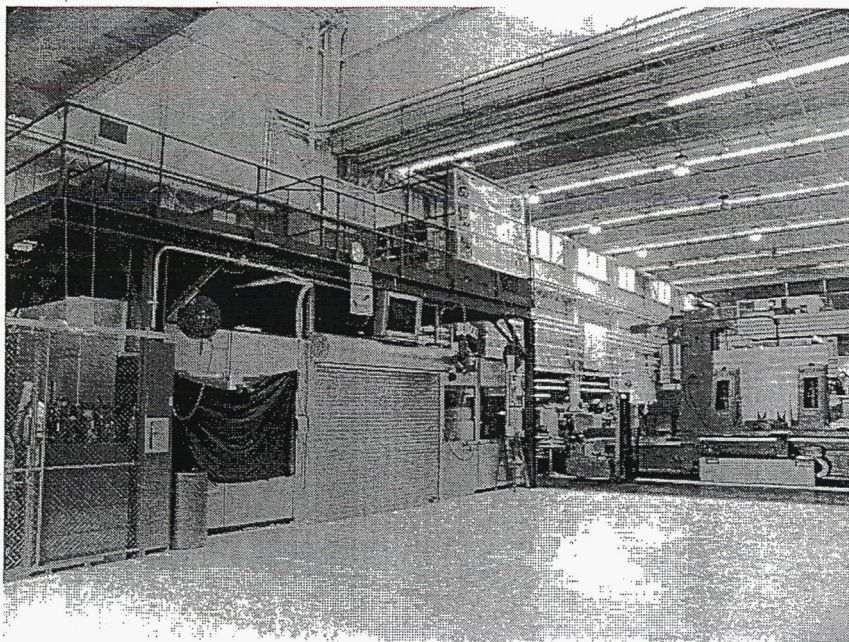
Figure 2 is a photograph of the room from the roll door looking toward the machine shop. The photo shows the current air return plenum on the exterior of the Yellow Room. The black plastic is used to keep the room dark for the frequent inspections/cleanings needed to control particles.

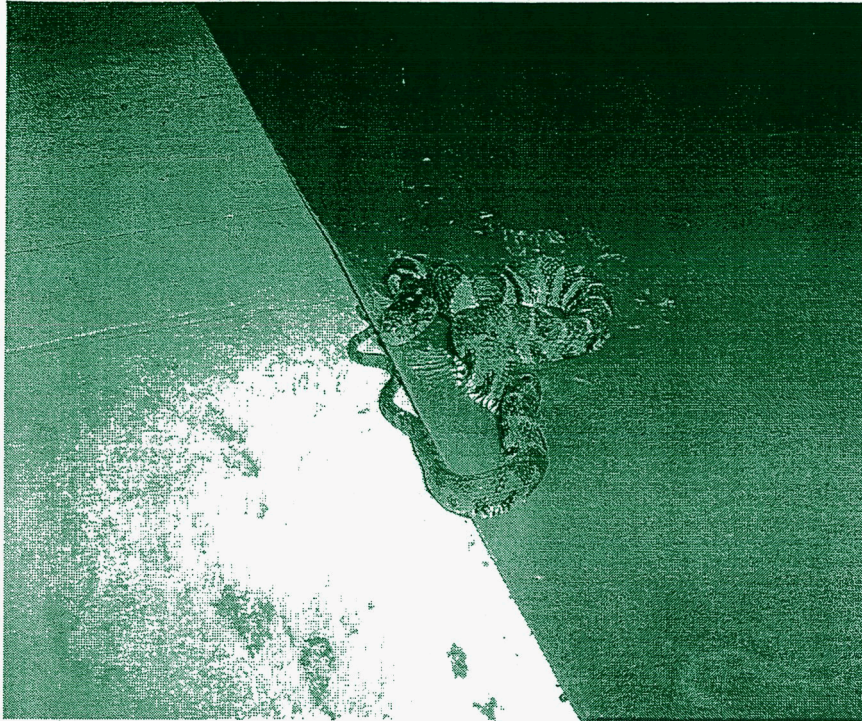
Figure 3

NASA was assembling two identical coronagraphs in this room. Soon after start of assembly, we encountered a fly infestation apparently due to the frequent openings of the high bay door. Several months later we encountered a mouse problem. A mouse had entered the room by chewing a hole in the tape over the hole in the corner of the Yellow Room roll up door. We found droppings and hair all over our work surfaces. Our problem was solved by a snake that ate the mouse and conveniently caught itself on the tacky mat in the entrance to the work area (Figure 3).

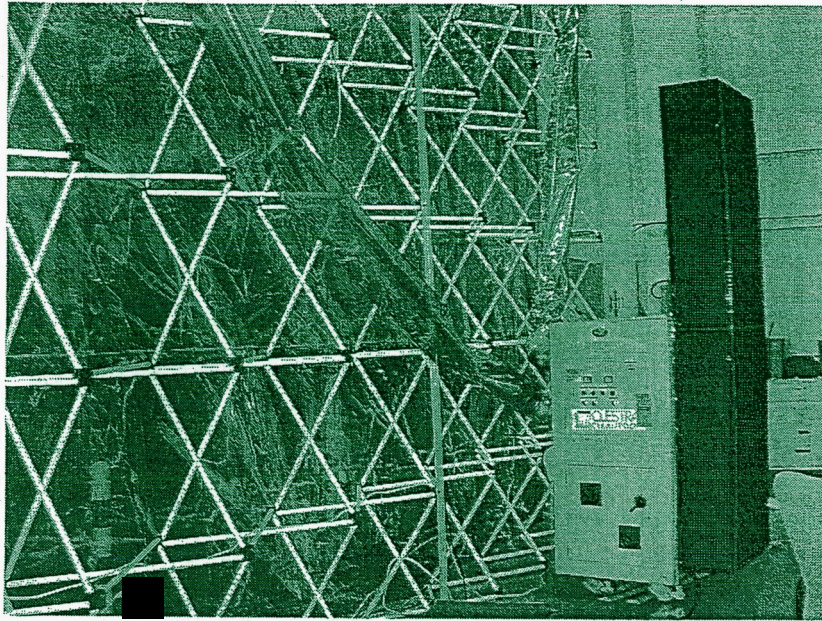
As you can see, it's not a clean tent. In spite of my protests, the project continued to develop this option. Figure 4 shows the portable air-conditioning unit (PAC) that was used to supply HEPA filtered air to the tent. The tent arrived with a material that carried a static charge. A major problem for an ESD sensitive

spacecraft. We had to hang metallized bagging film inside the tent to prevent damage to the spacecraft. The PAC could not supply enough air to make the tent comfortable for workers (or class 10000 for the spacecraft). Another PAC was brought in to circulate cold air and control humidity. The primary instrument on the spacecraft is ESD sensitive so it likes moist air but it's detectors are sensitive to moisture, so they like dry air. I suggested contamination covers for the instrument that would be purged. This enabled them to proceed. But the project was still plagued with humidity problems on the ESD side.

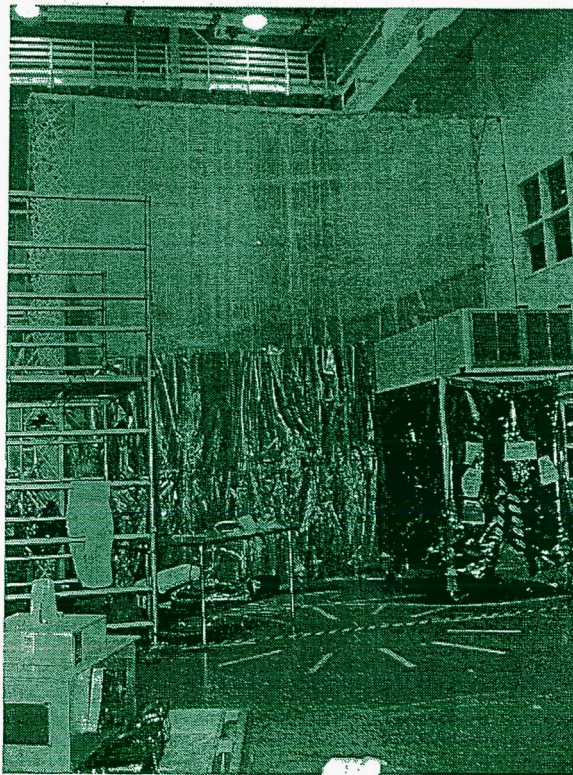
Figure 5

This spacecraft was not particularly sensitive to contamination. The project had proceeded for some time without a contamination engineer on board. At the insistence of the science team, I was called in to make an assessment of the situation. This occurred just before a vacuum test at cryogenic temperatures was begun to test the optical alignment stability at operating temperatures (70°K). My suggestion was to build the spacecraft in clean tent and delay the vacuum test until a method to prevent moisture from condensing on optics was developed. The recommendations were ignored as being too costly. After vacuum test, one of the optical elements exterior coating peeled off apparently due to moisture condensed inside the coating and then freezing. The project reconsidered my recommendations. At Goddard, we have a contractor administer our cleanrooms – Mantech. I began discussing modifying an existing clean tent for this project's use because on its fixture, the spacecraft was too tall for the current tents. The plan was to acquire higher jack stands and a longer tent for an existing down flow HEPA array. Then I made a mistake, I took a few days off. When I returned, the project had decided to not wait for the fix and chose to buy another tent. Figures 4 and 5 show the details of the tent the project had purchased.
